The Mars Climate Sounder In-Flight Positioning Anomaly

Bruno M. Jau* and David Kass**

Abstract

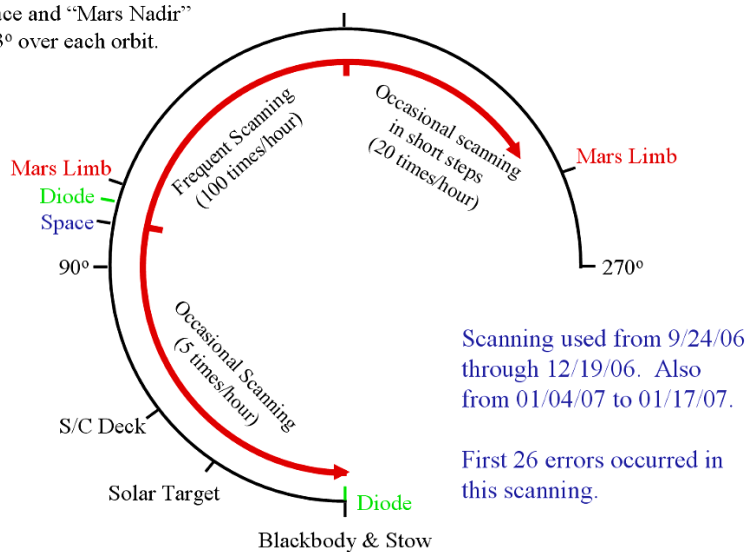
Figure 1: Range of Elevation Actuator Operation

The scanning is described in detail in [4], but a few locations played a key role in understanding the anomaly. A graphical representation of the range and frequency of scanning is shown in Fig. 1. The first position is the stow position. This is with both actuators pointing at 0°. This is a sun safe position that is used when the instrument is powered off, since even a momentary exposure of the telescopes will destroy the focal plane. It is also used when the instrument is standing down from normal operations.

When the elevation is at 0°, the telescopes are staring at the built-in black body, one of three calibration views. The second calibration target, the solar target, is at an elevation of 37°. The standard MCS scan observes the blackbody about five times per hour and the solar target once an hour.

Limb, Space and “Mars Nadir”
drift by $\sim 3^\circ$ over each orbit.

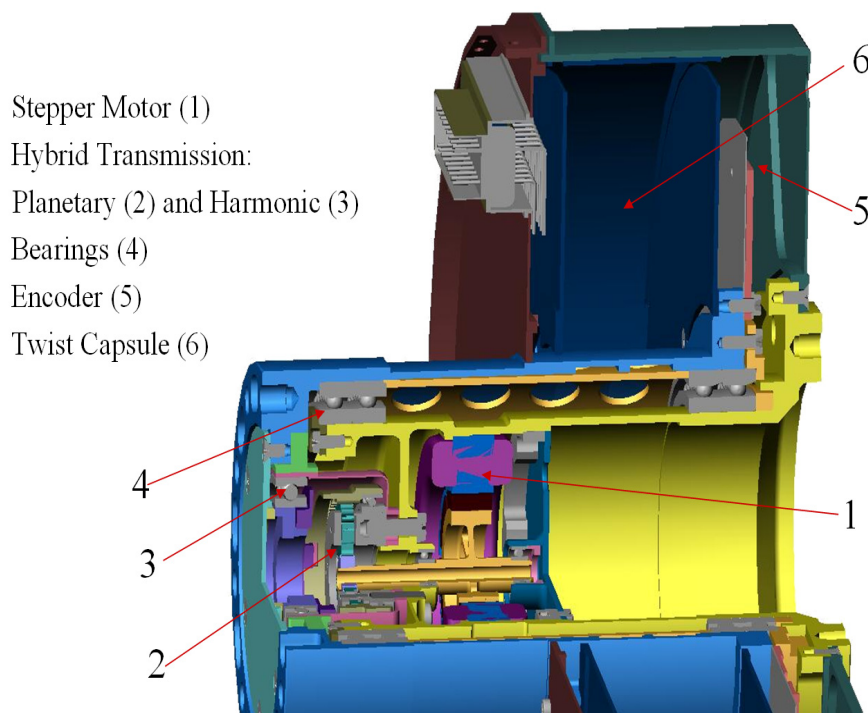
Figure 6: The Azimuth Actuator/Twist Cap

A disk (near item 5 in Fig. 6) normally blocks the light path between the light emitting diode (LED) and the phototransistor. The disk has one slot, allowing diode light to pass through when the slot passes a sensor. The slot size had to be made quite large (approx. 1-1/2mm) for sufficient light from the diode to pass through. Therefore, the sensor is triggered for up to six steps during each diode passage.

If the actual joint position does not correspond to the commanded position (due to whatever causes the anomaly), the position error has to be at least 3 steps away from the commanded position to be detected by this sensor system, having a 6 step diode trigger window. A sensed error reading is recorded but not reported immediately, thus complicating the error analysis (see “Error Discussion” below). Error cancellation is also possible if a subsequent error is in the opposite direction. However, if the flight software detects an error, it will reinitialize (see below), even if a subsequent error (hysteresis effect), should cancel it out.

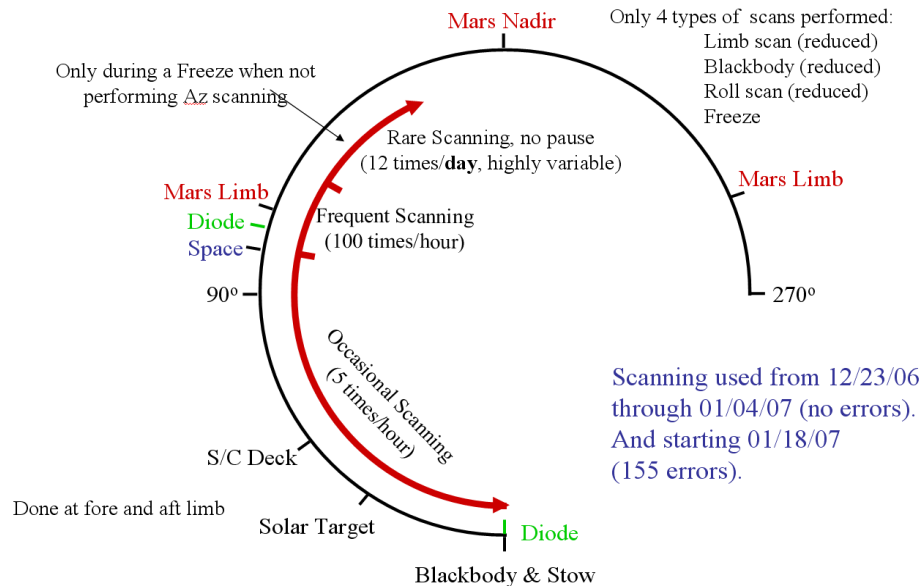
Figure 9: Range of Reduced Scanning

A “problem scan” diagnosis tree was developed to identify the slew or slews causing the errors. It was also designed to determine if there were operational workarounds for the position errors. The first step was to use a reduced set of scanning (Fig. 9) that only involved using a blackbody scan and a limb scan, both limited to 10° below the limb. For sun safety reasons, freeze

commands were still allowed to cause occasional scanning up to 35° below the limb. This scan pattern was designed to rule out one of the three candidate scans. Additional steps were designed to differentiate between the other two scans.

The reduced scanning was started on Dec. 22; it ran over the holidays without producing any errors. The next steps of the tree were started on Jan. 2, but still failed to produce additional position errors. Concerned that the results of the steps in the diagnosis tree were misleading the full scanning pattern was tested on Jan. 4. This did not generate any position errors until the morning of Jan. 16.
